Manhole Inspection Summary

Manhole # S21YY1042MH

Record Plat: **21YY1** Node: **042** Status: **New Manhole (Not in GIS)** Insp Date: **11/28/06 12:00 AM**

Location Address: **111 CROSSKEYS RD** Cross Street: **ROLAND MEWS**

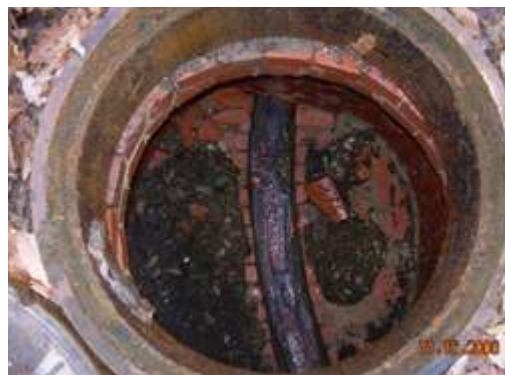
Top View

Frame leaks. Frame offset. Adjustment deterioration and infiltration. Corbel and Barrel infiltration. Evidence of surcharge.

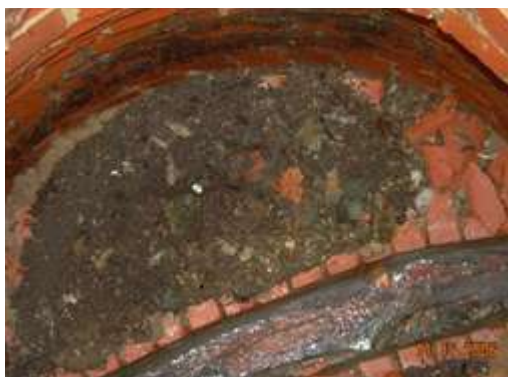
Defect

Surcharge ☒ **Evidence Of Surcharge** Depth: **1** (ft.) ☐ Active Surcharge Present

Evidence of surcharge - Bench debris.

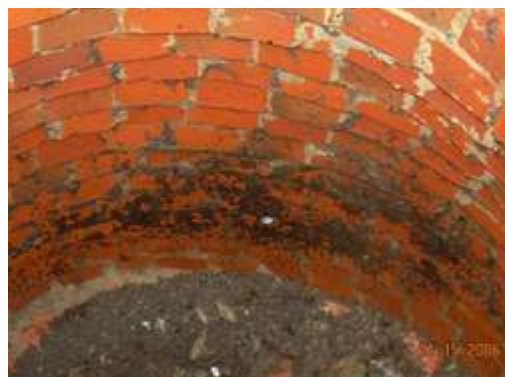
Defect

Barrel Material: **Brick** ☐ Parged
Shape: **Circular** Diameter: **42** (in.) Length: (in.)
Condition: ☒ Sound ☐ Cracked ☐ Root Intrusion ☐ Loose Brick ☐ Deteriorated
Infiltration: ☐ None ☒ **Joint** ☐ Cracks ☒ **Mortar** ☐ Roots ☒ **Wall**

Barrel infiltration.

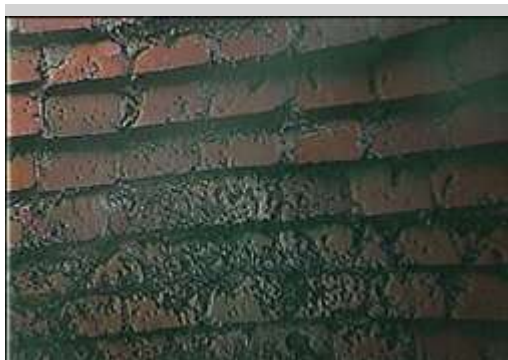
Defect

Corbel Material: **Brick** ☐ Parged Type: **Concentric/Eccentric**
Condition: ☒ Sound ☐ Cracked ☐ Root Intrusion ☐ Loose Brick ☐ Deteriorated
Infiltration: ☐ None ☐ Joint ☐ Cracks ☒ **Mortar** ☐ Roots ☒ **Wall**

Corbel and Barrel infiltration.

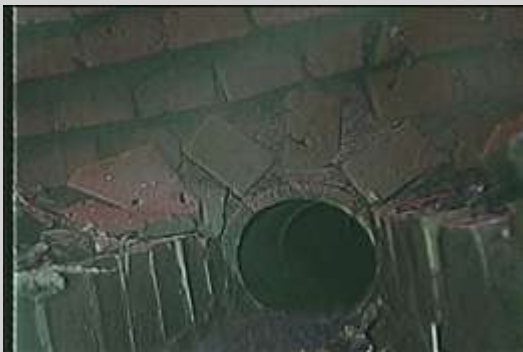
6 in. Circular Gravity Sewer Pipe Out @ 12 O'Clock

Infiltration: **Evidence** Pipe Seal Cond: **Unknown**

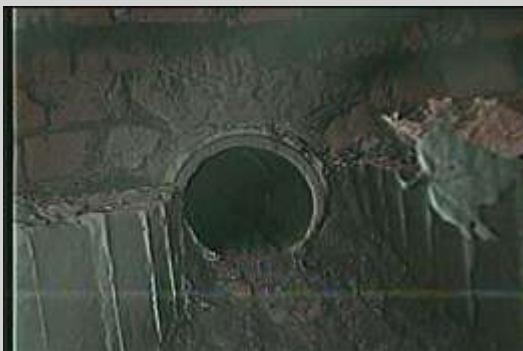
6 in. Circular Gravity Sewer Pipe In @ 5 O'Clock

Infiltration: **Evidence** Pipe Seal Cond: **Unknown**
